Equipment Safety Recall

N222359640 Tonneau Cover Retention

Release Date: March 2022

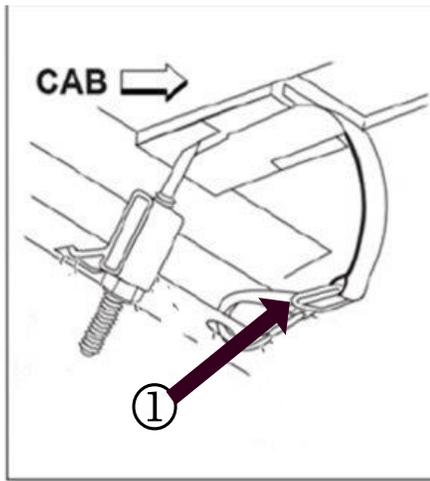
5613815

Hard Tonneau Cover Tether

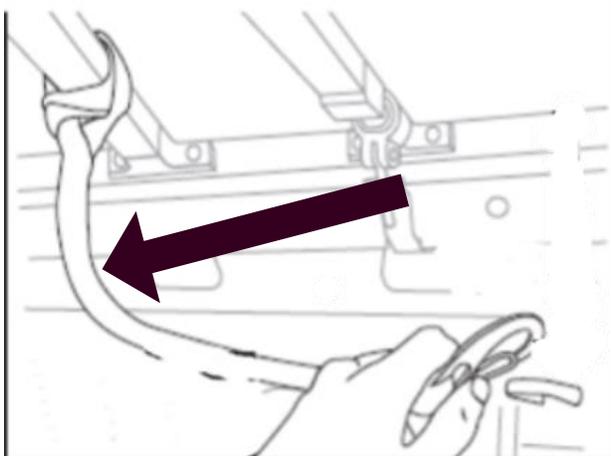
6023461

Soft Tonneau Cover Tether

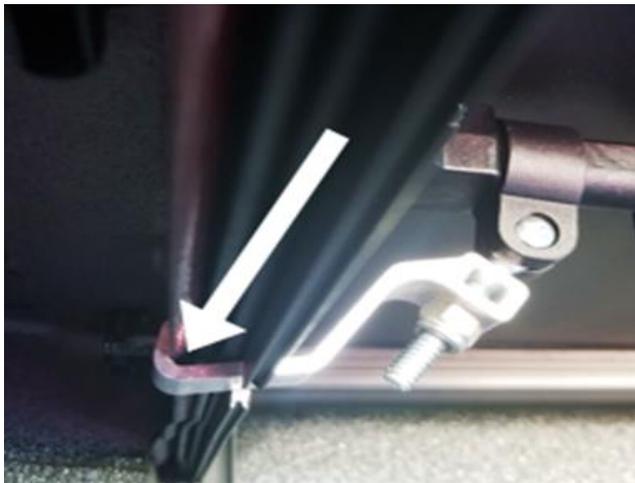
5448624

Correct installation of bracket clamp hook

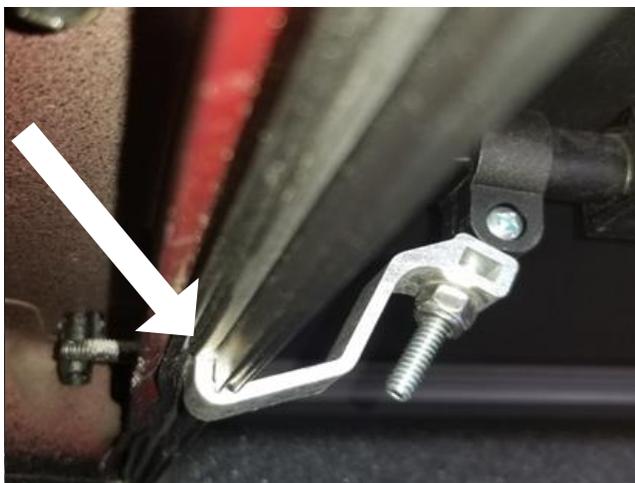
5448625

Incorrect installation of bracket clamp hook

9. If any of the above inspections indicate an incorrect clamp hook installation, loosen the nut on the threaded mount and position the clamp hook in the correct position. Hand tighten the fasteners.
10. Position the cover evenly side to side and rest the cab seal smoothly along the front top edge of the cargo bed.
11. Tighten the nuts until the clamp hooks are secure against the bed rail flange. Tighten each side evenly, tighten only until the tonneau cover cannot shift. **DO NOT** overtighten, overtightening may cause damage to the clamping system.
12. Close the tonneau cover and tailgate.

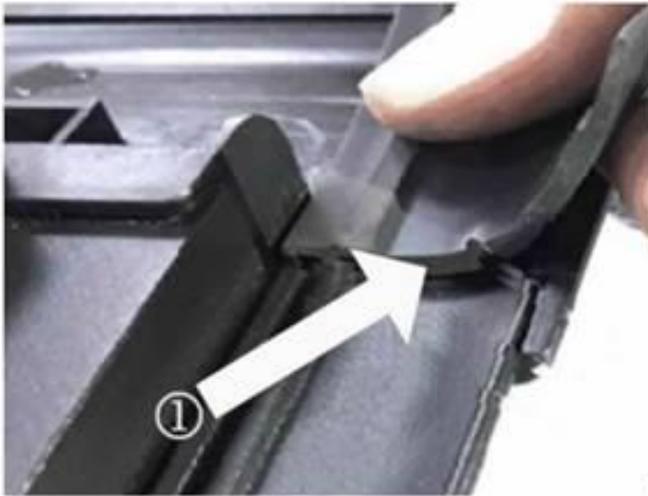
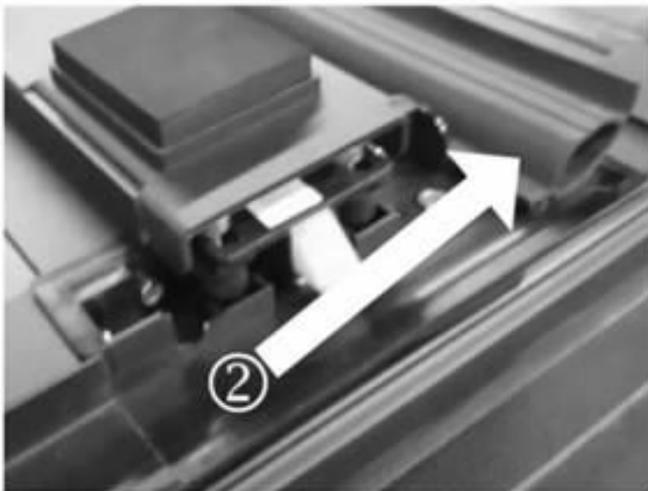
Important: Verify the front tonneau cover seal is the revised “fin” style seal (1). If the “bulb” style seal is installed (2), replace the seal. Refer to steps 1-5 of the Adjustment Instructions for Vehicles That Have NOT Had Recall N192217500 performed below.
